Wissenschaftliche Berichte
FZKA 7307

Results of the QUENCH-12 Experiment on Reflood of a VVER-type Bundle

**Institut für Materialforschung
Programm Nukleare Sicherheitsforschung**

September 2008

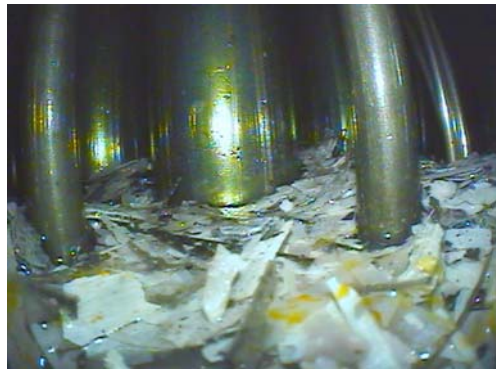
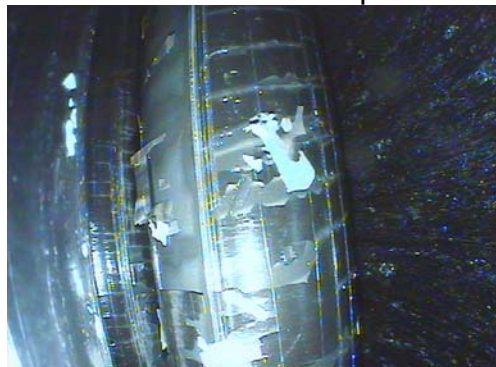
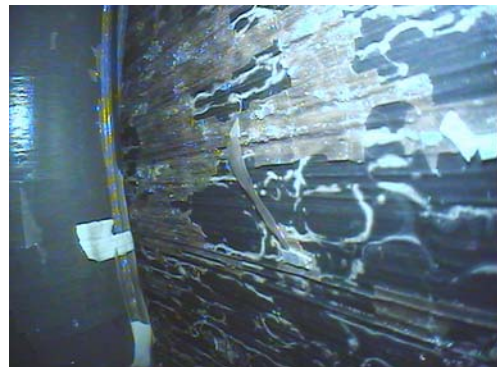
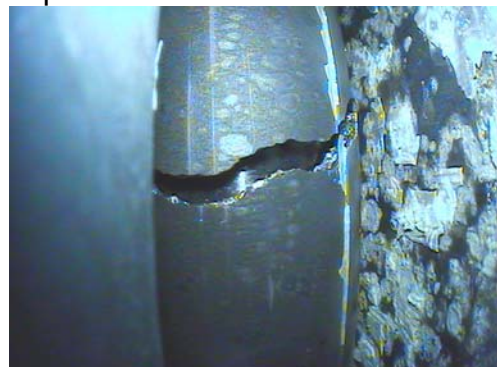
Fig. 36: QUENCH-12; Videoscope monitoring (side view) at the empty position of the withdrawn corner rod D.

debris on bottom of separator

bottom of unheated rod

spallations at cladding at 400 mm

spallations at shroud at 400 mm

spallations at shroud at 850 mm

rod16 break at 900 mm

Spallation of the oxide scale was also observed with help of a videoscope (OLYMPUS IPLEX) inserted at the empty positions of the three withdrawn corner rods. Spalled oxide scales were even partially removed by pull-out of the videoscope from the bundle. [Figs. 34-36](#) show photographs of typical structures from different bundle elevations taken at the empty position of the withdrawn rod D. The lowest elevation where breakaway oxidation of cladding surface took place was at ~400 mm. The maximum temperature at this bundle position was about 1123 K. No spallation of oxide layer was observed at hottest bundle elevations between 800 and 1000 mm. However the shroud surface at these elevations was exposed to nodular breakaway oxidation. The majority of debris from claddings and shroud accumulated at the bottom of the bundle and upper edge of grid spacers. Particularly, the grid spacer at 550 mm elevation acted as a debris catcher. The initially coarse shroud surface revealed thicker spalled oxide scales, when compared to the simulator rod cladding.

cladding cracks were found in the hot bundle zone between 700 and 1000 mm (last photos in Figures 35 and 36).

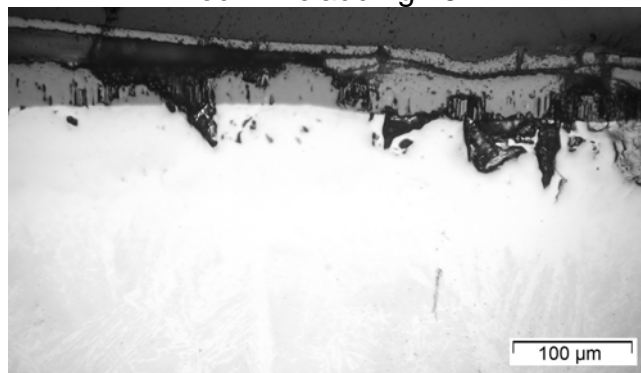
Rod 21, 45°: external oxide scale spalling
